Intel[®] Pentium[®] III Xeon[™] Processor Specification Update

Release Date: May 2000

Order Number: 244460-015

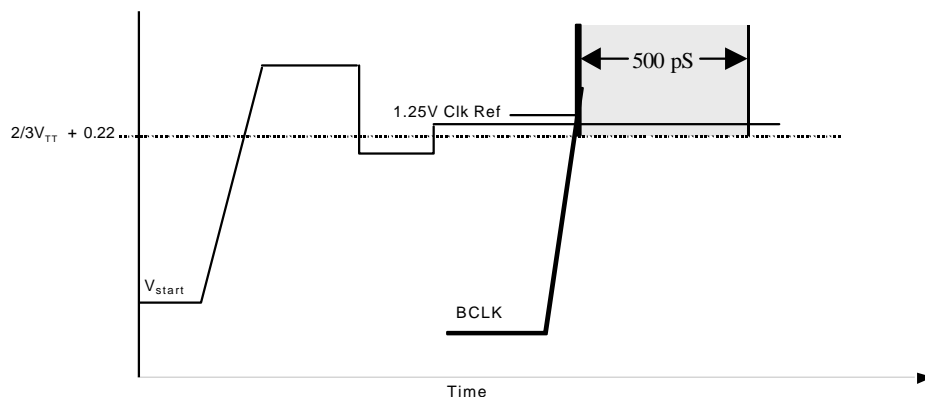
The published AGTL+ AC specification for $V_{IH(MIN)}$ is $(2/3 \cdot V_{TT}) + 0.1$ Volts.

Intel has characterized the new AGTL+ AC specification for $V_{IH(MIN)}$ on the processor's RS0# signal to be: $(2/3 \cdot V_{TT}) + 0.22$ Volts within 500 picoseconds following the rising edge of BCLK crossing the 1.25-Volt threshold. See below.

Implication: The deviation from the published specification results in decreased noise margin on the RS0# processor input. This decreased noise margin has been observed to be particularly detrimental in system environments where the RS0# processor input is being driven by an I/O buffer with a pull-up device (such as a p-channel transistor) that is switched off mid-cycle. Systems that employ I/O buffers that keep the pull-up device on for the entire cycle are significantly less affected by this erratum. The reduction in noise margin may lead to the generation of BINIT# (when enabled) resulting in a system reset, otherwise this condition may lead to a system "hang" condition.

Workaround: If a system design cannot meet the specification deviation, the following areas should be carefully examined to assure that additional margin exists in order to compensate for any deficit observed with respect to the newly characterized $V_{IH(MIN)}$ specification:

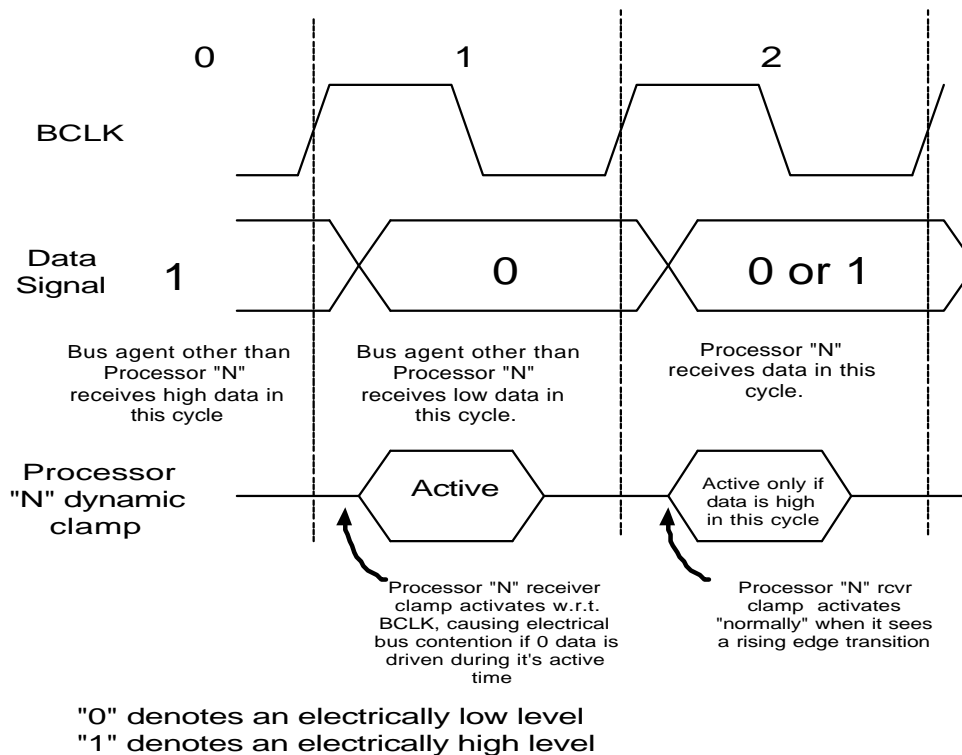
Problem: Falling edge ledge push-out and undershoot may be seen on AGTL+ data and data bus ECC signals. The AGTL+ receiver's dynamic clamp circuit activates (i.e. clamps the signal to an electrically high level) in certain cycles when data is driven to an electrically low level by another agent.

Implication: This erratum only occurs on a processor that does not receive data in that particular cycle. More specifically, this erratum only occurs when a specific processor does not receive data in the current BCLK period, but receives data in the very next period. Therefore, the processor inducing this falling edge noise (on data and data bus ECC signals) will not actually read the data in that cycle. See below for an illustration of this erratum affecting a processor denoted Processor "N". The falling edge ledges and undershoots may affect the signal quality and/or timing at agents that receive data in that cycle. Therefore, the impact of this erratum is highly dependent on system bus design.

Workaround: Evaluate system bus signal quality and timing margin at the valid receiving agent as a result of this falling edge noise. Due to dependence upon system bus design, bus layout may be evaluated to determine the need for improvements in signal quality and timing margin at the valid receiving agent as a result of this receiver-induced falling edge noise.
